Guidelines for Buildings

Exterior Wood

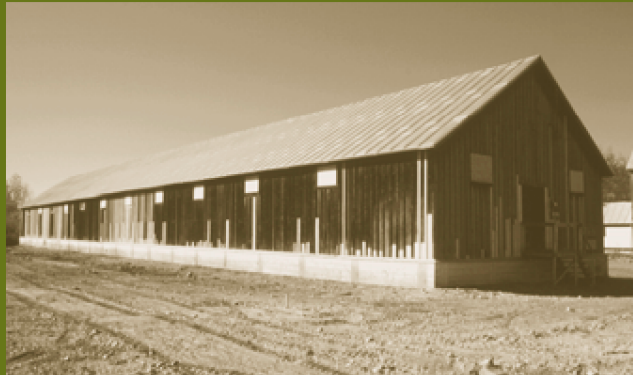
Maximizing the retention of character-defining materials and features is the primary goal of *Preservation*, as demonstrated in this photograph. Work on this wooden warehouse consisted primarily of minor repairs to the foundation skirting and limited replacement of deteriorated material. The new wood will be left to weather to the same appearance as the old.

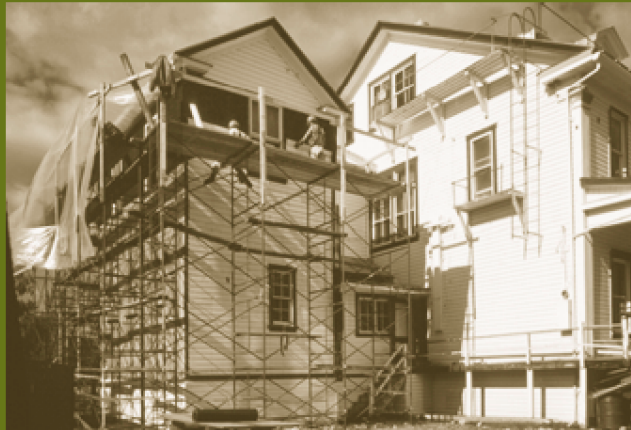
The extensively deteriorated wood siding on the exposed side of this building was replaced in kind. The new wood siding matches the surviving siding in form and detailing.

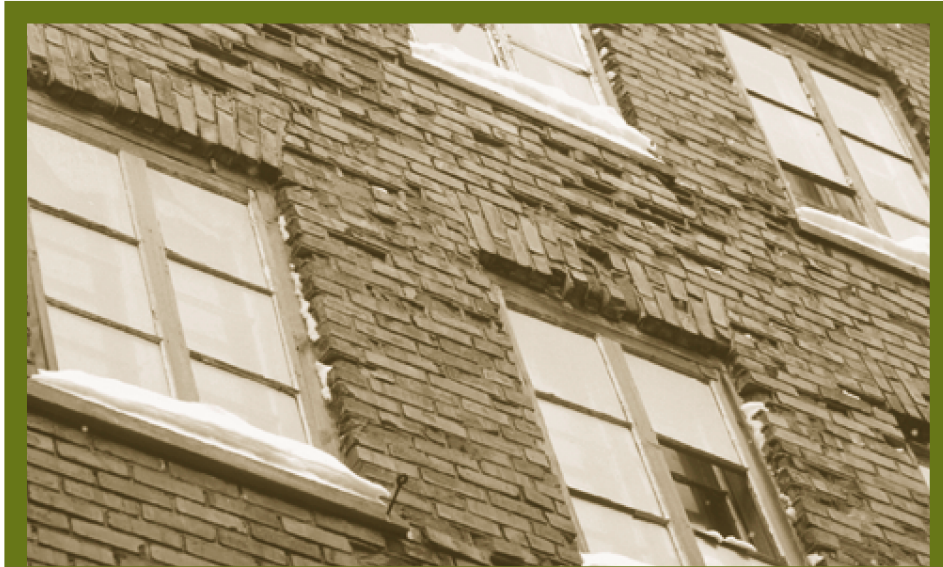
The harsh climate in many parts of Canada can seriously damage masonry elements. This wall in Quebec City has suffered irreversible damage from water penetrating the brick façade and freezing, causing the faces of many bricks to pop off. To avoid damage such as this, it is recommended that moisture penetration be stopped by repairing failed flashings, deteriorated mortar joints or other mechanical defects, not by applying water-repellent coatings, which can trap moisture inside the masonry.

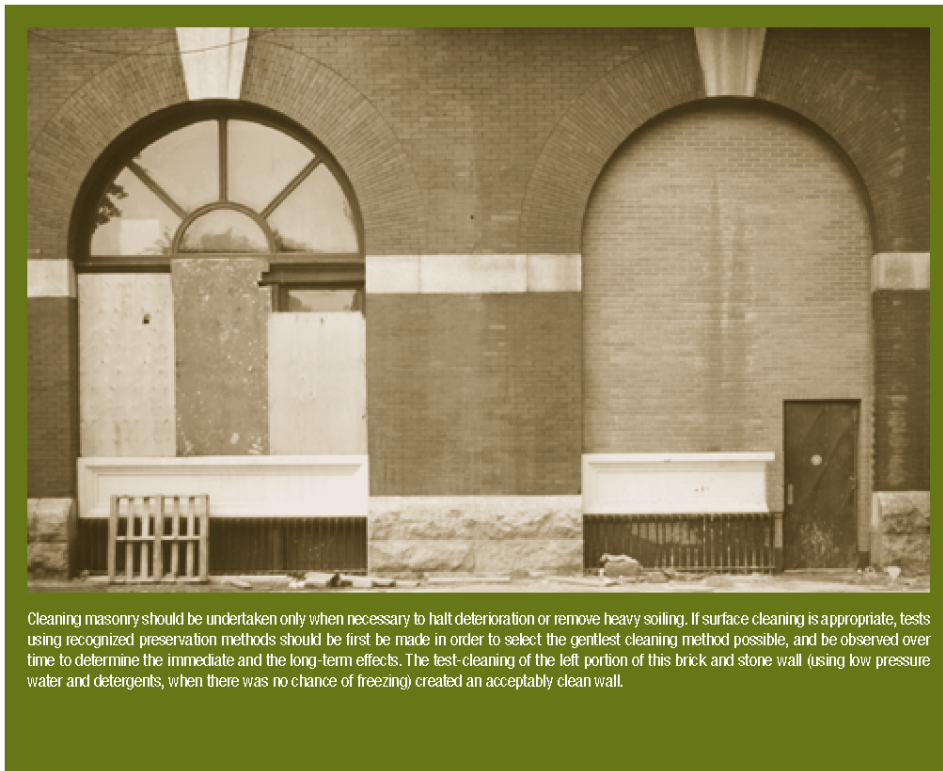
Cleaning masonry should be undertaken only when necessary to halt deterioration or remove heavy soiling. If surface cleaning is appropriate, tests using recognized preservation methods should be first be made in order to select the gentlest cleaning method possible, and be observed over time to determine the immediate and the long-term effects. The test-cleaning of the left portion of this brick and stone wall (using low pressure water and detergents, when there was no chance of freezing) created an acceptably clean wall.

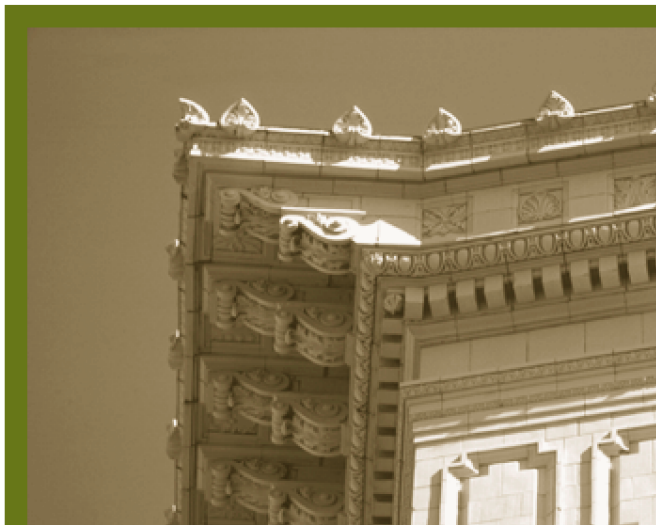
One of the primary causes of deterioration of glazed architectural terra cotta is water. Water-related damage to the glazed units, mortar, metal anchors or masonry backfill can be repaired only when the sources of that water have been eliminated. This typically means repairing flashing, repointing deteriorated mortar with a mortar that has a compressive strength lower than the adjacent masonry unit, and coating or sealing blistered spots to prevent further entry of water. Repointing with waterproof caulking compounds or the wholesale coating of the wall with waterproof materials will impede the normal outward migration of moisture through the masonry joints and likely cause spalling of the glaze or mortar.

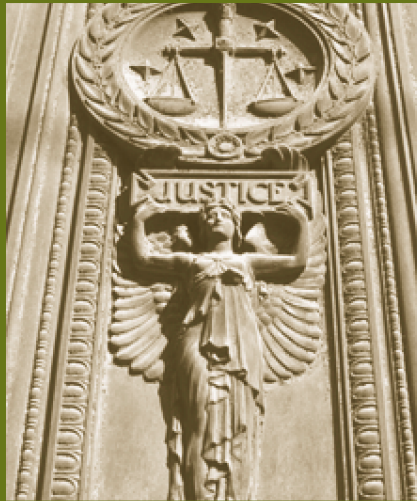
The first step in *Preserving* architectural metals is to identify the type of metal. Before cleaning, determine that cleaning is appropriate for the particular metal: removing the patina from the bronze door shown above would not be appropriate if the patina is a character-defining finish of the metal, or if it provides a protective coating. If cleaning is appropriate, testing is recommended to ensure that the gentlest cleaning method possible is used.

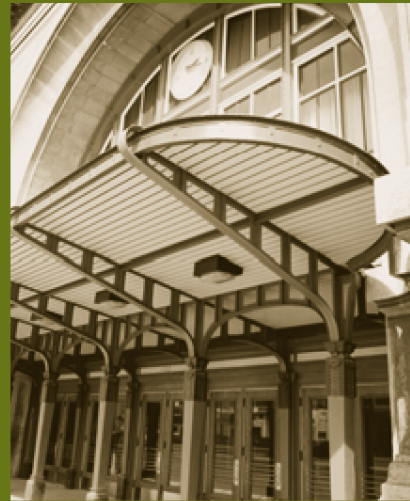
A regular programme of cleaning and re-applying appropriate paint has preserved to a remarkable degree the metal entrance canopy of Winnipeg's Union Station, which was completed in 1911. Protection from corrosion should be considered the first line of defence in preserving architectural metals.

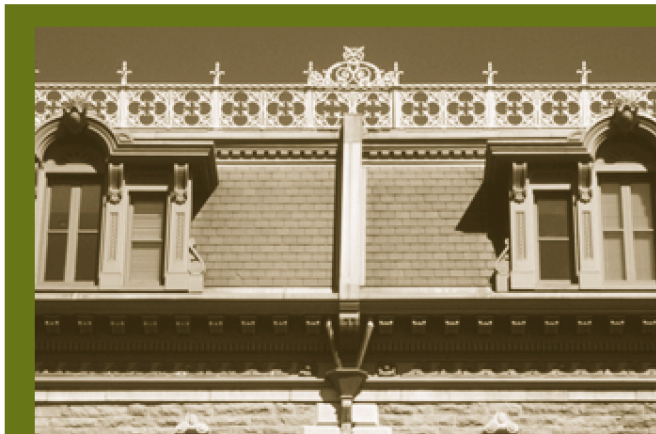
In *Rehabilitation*, replacing in kind an entire architectural metal element that is too deteriorated to repair is recommended, if the overall form and detailing are still evident. Missing metal roof cresting on the Shaughnessy House in Montreal was replaced by using existing physical evidence as a model to reproduce the element.

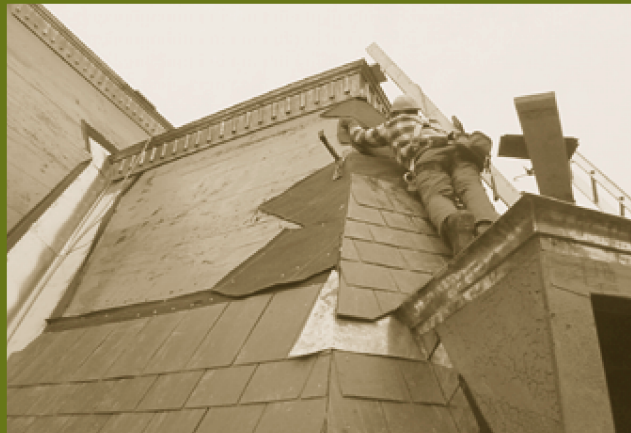
The *Rehabilitation* of the Truro Federal Building, in Truro, Nova Scotia included restoring its distinctive slate roof. In *Rehabilitation*, the replacement of missing historic features with a replica based on physical and documentary evidence, as in this project, is acceptable, as is a new design that is compatible with the character of the historic place.

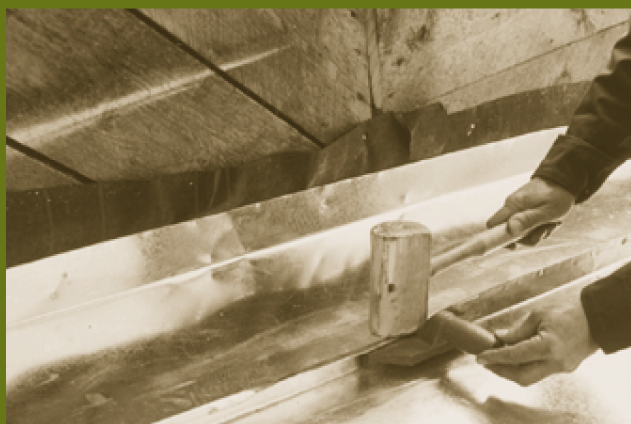
During the *Restoration* of the former post office in Dawson, Yukon, the metal roofing surface, which was too deteriorated to repair, was replaced "in kind" (using the same form, materials, and detailing). Physical evidence from the *Restoration* period was used as a model to reproduce the characteristic standing seam detail.

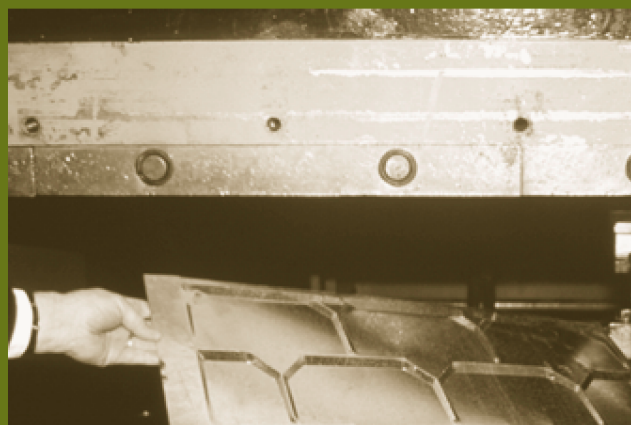
A surviving pressed metal shingle was used as a prototype for manufacturing replacement shingles for the *Restoration* of the main house at the Motherwell Homestead near Abernathy, Saskatchewan. As a rule, in *Restoration*, repairs or replacements of extensively deteriorated or missing parts of features are done in kind, and are based on physical, documentary and oral evidence.

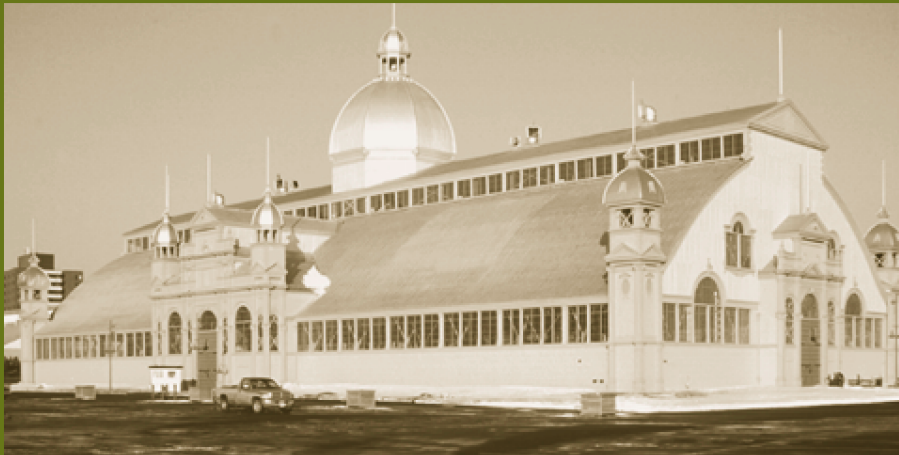
Preserving a building's character-defining windows generally involves scraping, sanding, re-puttying and repainting. While some limited repair and replacement work was undertaken within the scope of work on the Aberdeen Pavilion in Ottawa (photo on left: before, photo below: after), almost all of the windows were retained, including the glass. Wholesale replacement of window units is not an appropriate *Preservation* treatment.

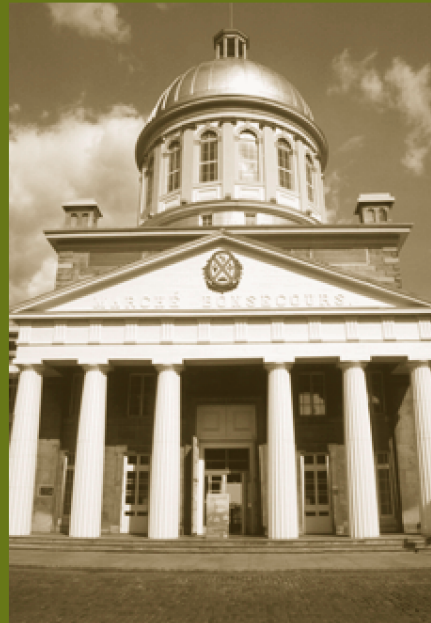
Porches, such as this portico on the old Bonsecours Market in Montreal (built 1844-47) with its striking Greek Doric cast iron columns, can play a very significant role in defining the character of a building. Maximizing the retention of character-defining elements, including the portico, was the primary conservation objective when the building was rehabilitated for use as a Municipal office.

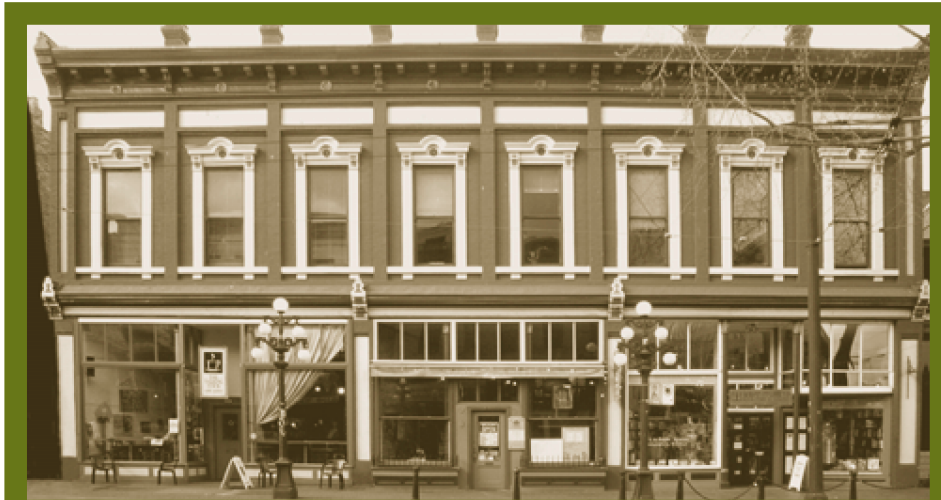
The character-defining form and features of 1880s storefronts in Vancouver, including their large plate-glass display windows with multi-pane transom windows above and recessed central doorways, have been retained through *Preservation*.

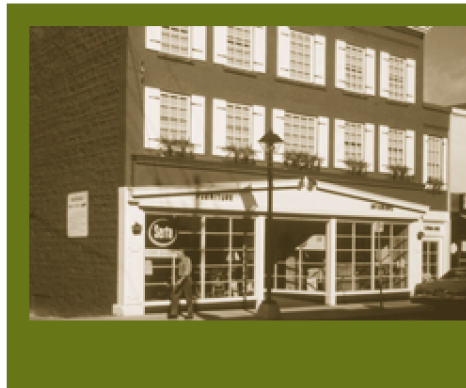
Creating a false sense of history, such as adding features based on 18th century American architecture to a 19th century Canadian building, is not recommended.
