Office of the Auditor General / Bureau du vérificateur général

AUDIT OF BRIDGE MAINTENANCE PROCESS

FOR A SPECIFIC BRIDGE

2009

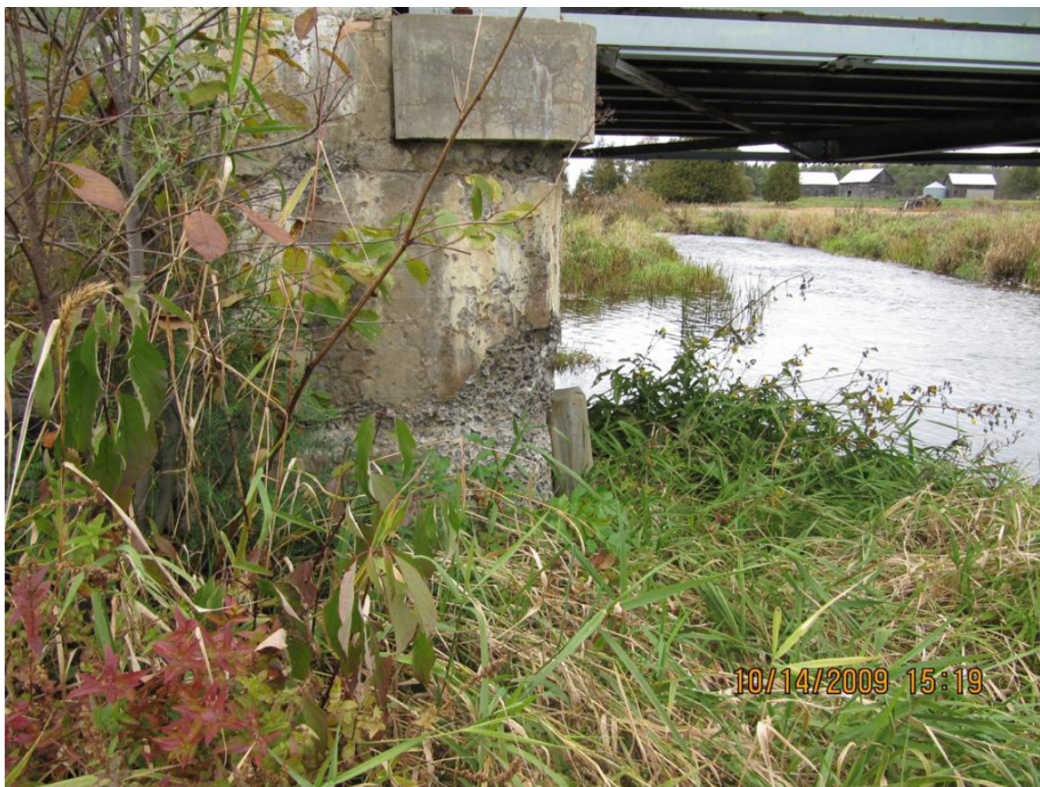
South end of west abutment

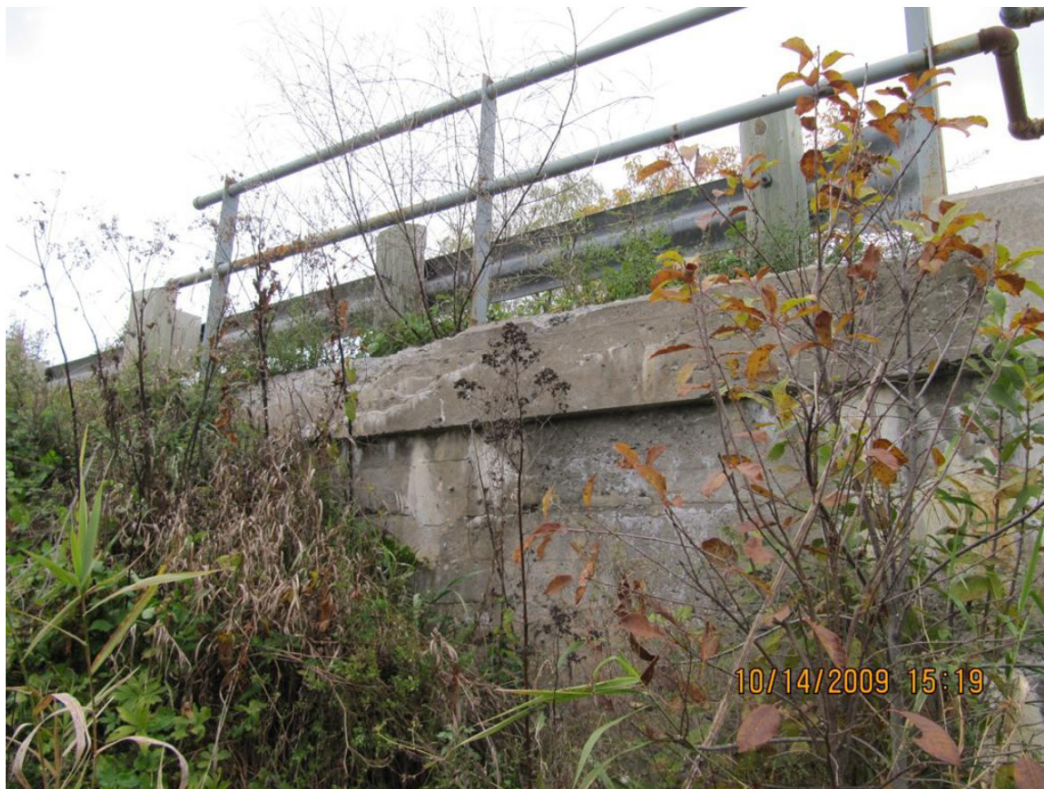
South west wingwall

| <u>Component</u> | <u>Rating</u> | <u>Comments</u> |
|---|---|--|
| 19. Wing Walls | 4 | Cracks and stain visible (efflorescence). Small spalls. Concrete deterioration as southwest and southeast corners, Picture 1 of heavy deterioration at northwest corner. |

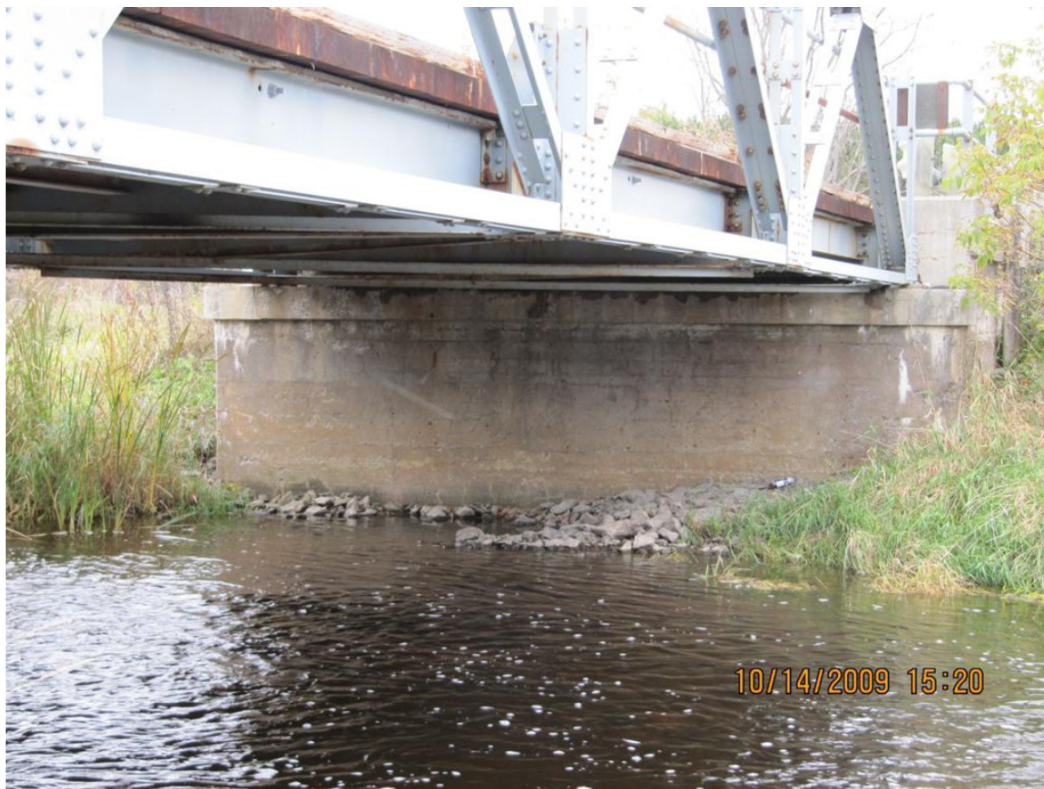
View of east abutment

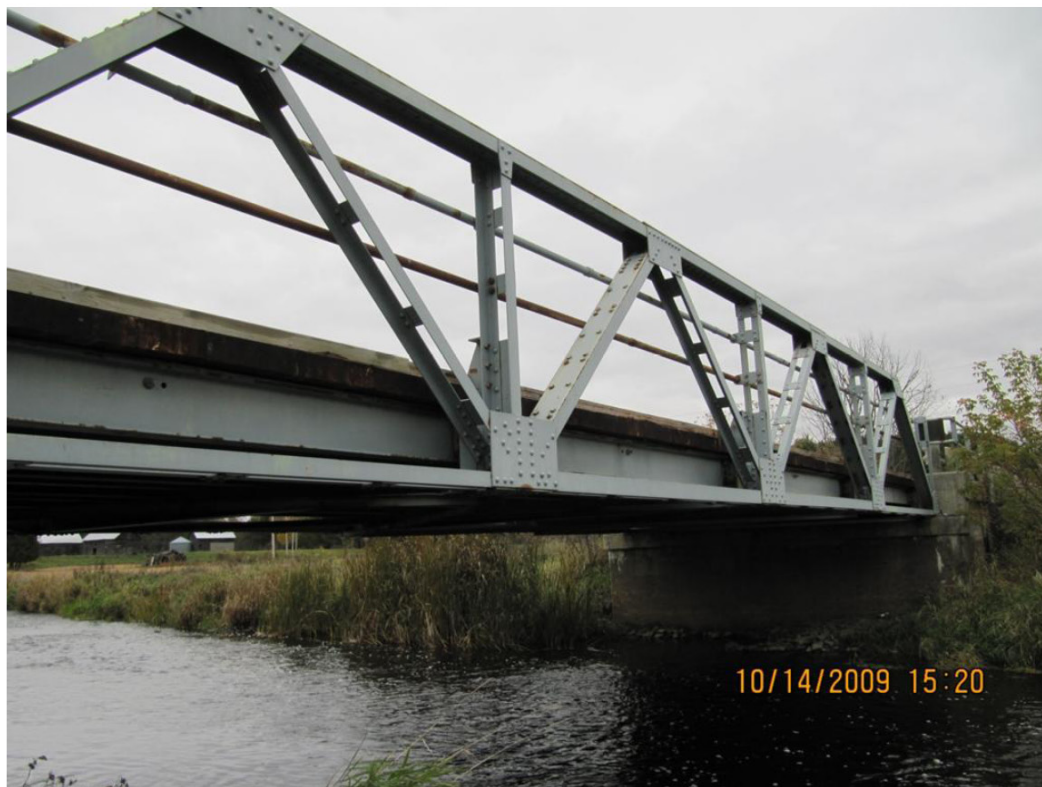
South elevation

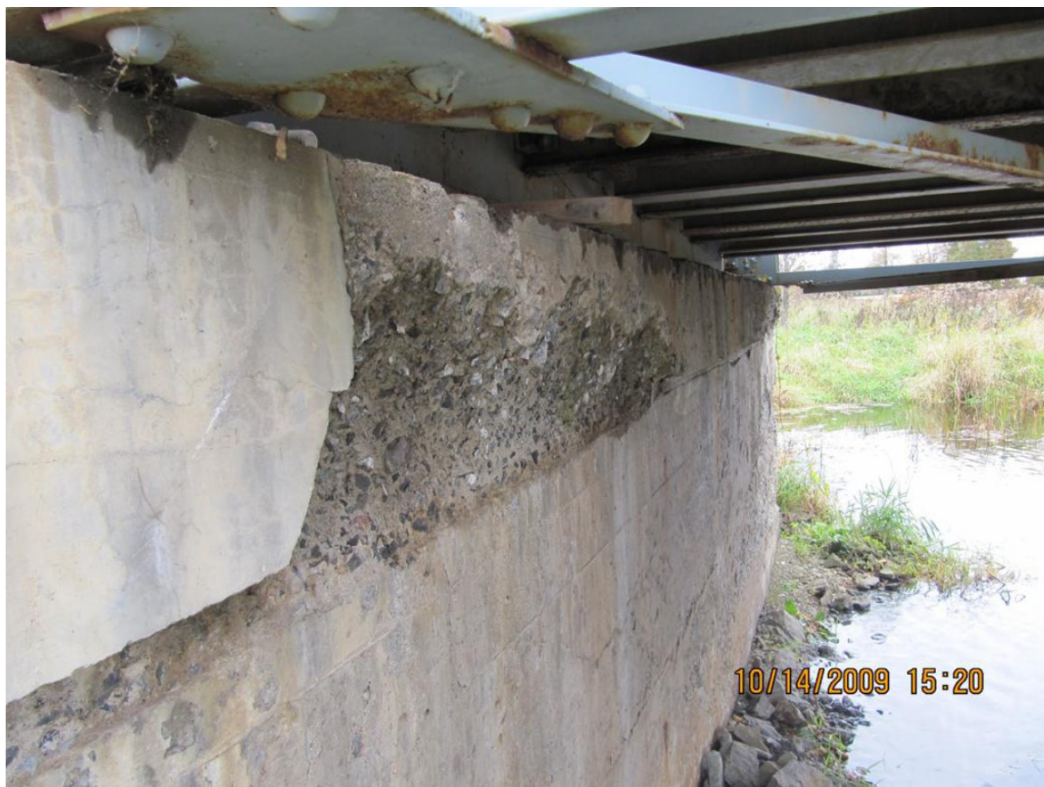
West abutment

| <u>Component</u> | <u>Rating</u> | <u>Comments</u> |
|---|---|--|
| 18. Main Wall | 4 | Numerous cracks and scaling. Map cracking at repairs. Cracks and delaminations at top of abutment face. |

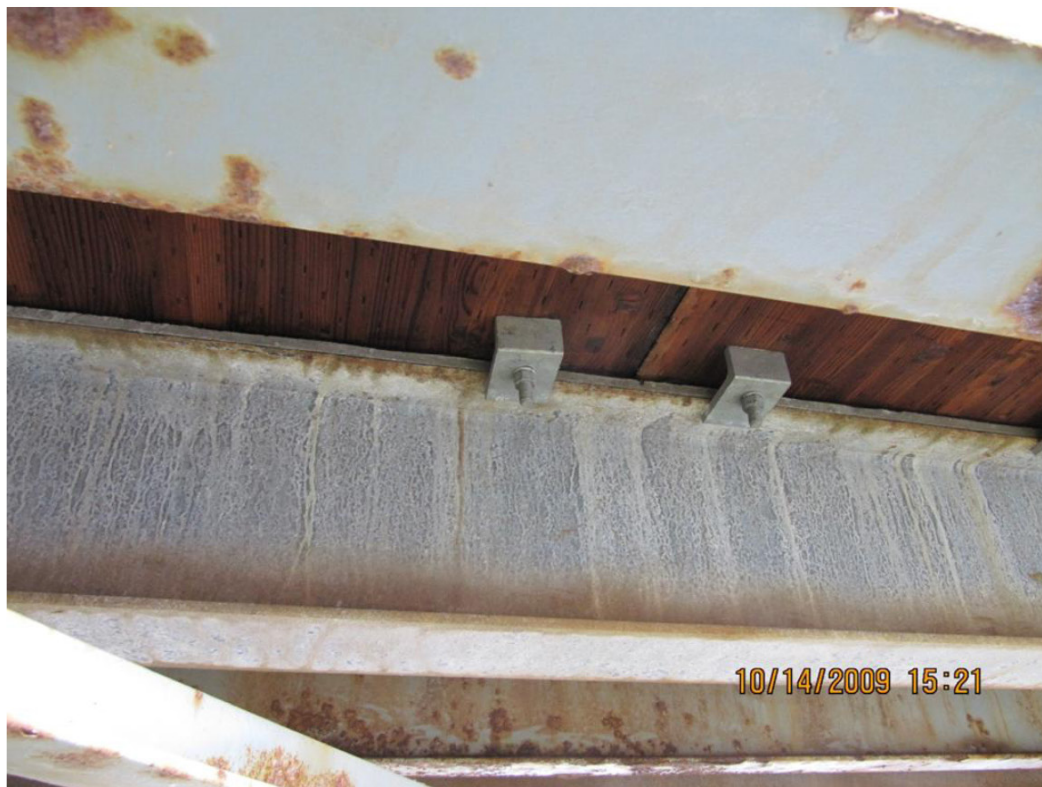
Detail of steel stringer and deck clip

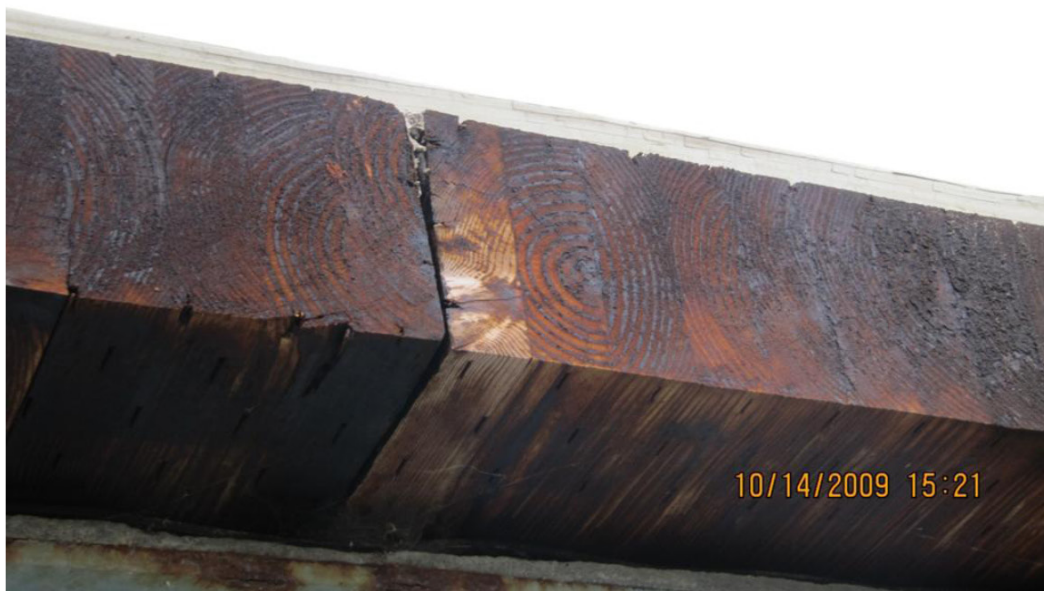
End view of timber deck (south side)

| <u>Component</u> | <u>Rating</u> | <u>Comments</u> | <u>Recommendations</u> |
|---|---|--|---|
| 34. Fascia | 5 | End of deck timbers: Splits with some broken ends. | |

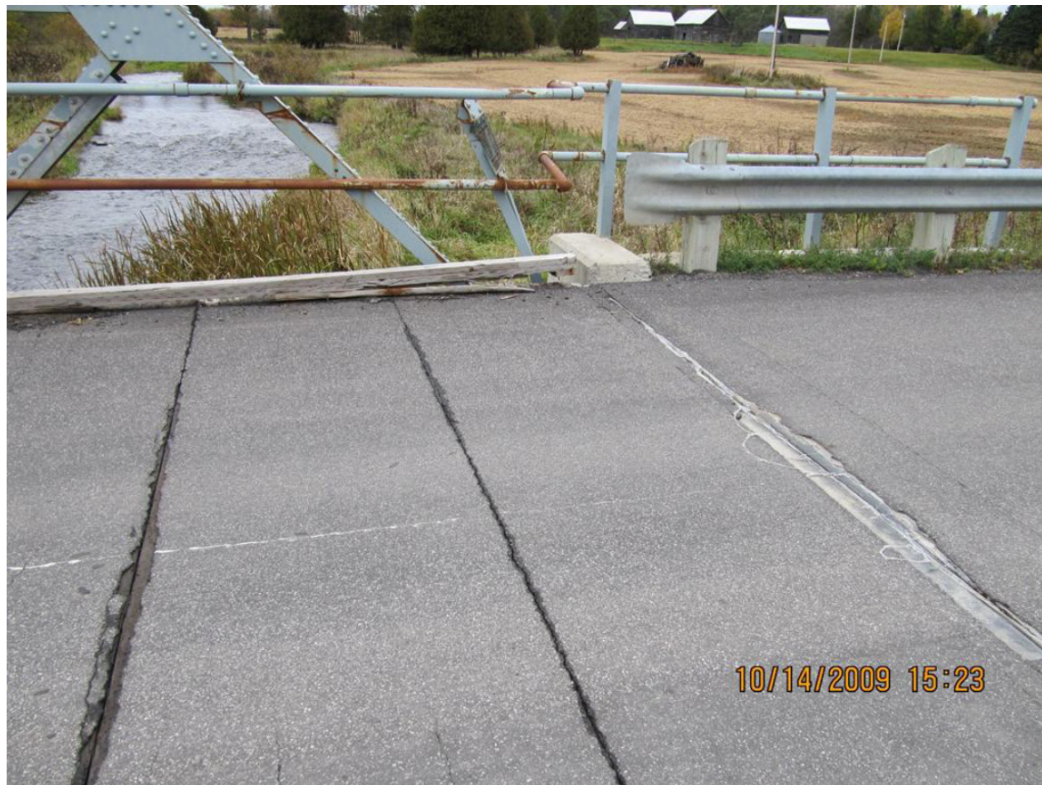
View of deck, north curb and barrier, east expansion joint

| <u>Component</u> | <u>Rating</u> | <u>Comments</u> | <u>Recommendations</u> |
|---|---|--|---|
| 28. Expansion Joints | 4 | Deteriorating compression seal and plow damage of armouring. | Replace seals |
